# LISTing Newsletter

Newsletter of the Long Island  
Sinclair/Timex Users Group

January 1994 Issue  
NEXT MEETING JAN 9, 1994

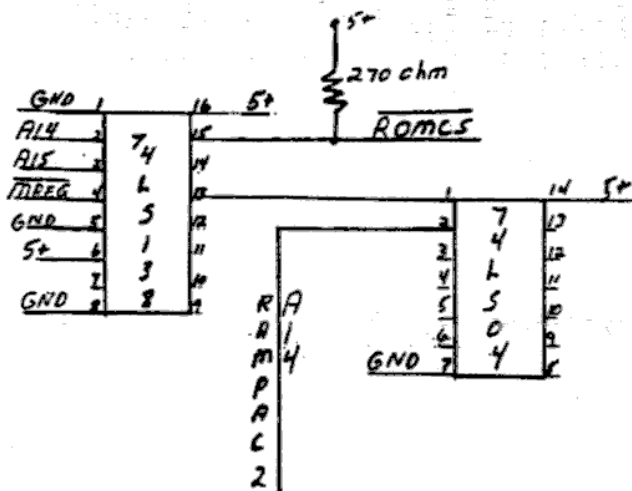
TS 1000 Memory Expansion - D. Dailey

THIS CIRCUIT WILL ENABLE A SECOND 16K TIMEX RAMPACK FOR 32K OF  
BASIC PROGRAM RAM. FIRST YOU NEED SOME WAY OF SPLITTING THE EDGE  
CONNECTOR SO THAT YOU HAVE TWO PLACES TWO PLUS ON THE RAMPACK'S AND  
A THIRD FOR A THROUGH CONNECTOR. RAMPACK ONE (16 TO 32K) WILL  
CONNECT AS NORMAL WITH NO INTERUPTION TO IT'S SIGNALS. RAMPACK TWO  
(32 TO 48K) WILL HAVE ALL IT'S NORMAL CONNECTIONS EXCEPT THE A14  
LINE. THE OUTPUT FROM PIN TWO OF THE 74LS04 IS SUBSTITUTED FOR  
THE A14 LINE TO THE SECOND RAMPACK. AS WIRED ABOVE, THE 74LS138  
WILL DECODE ADDRESSES IN 16K CHUNKS. THE OUTPUT FROM PIN 15 IS  
FOR NON DECODING. IF YOU HAVE ANOTHER BOARD IN USE THAT DECODES  
THE NON TIMEX CONNECTION IS NOT NECESSARY. THE 74LS04 IS A HEX  
INVERTER TO CHANGE THE ACTIVE LOW SIGNAL FROM THE 74LS138 TO  
ACTIVE HIGH. THE TIMEX RAMPACK'S DRAW ALOT OF CURRENT, SO  
DEPENDENT ON HOW MANY BINKS YOU HAVE PLUGGED IN, YOU MAY CONSIDER

PROVIDING A SEPARATE POWER SUPPLY (+5 & +9). THE MOD WORKS FINE  
ON A MAC T/S 1000.

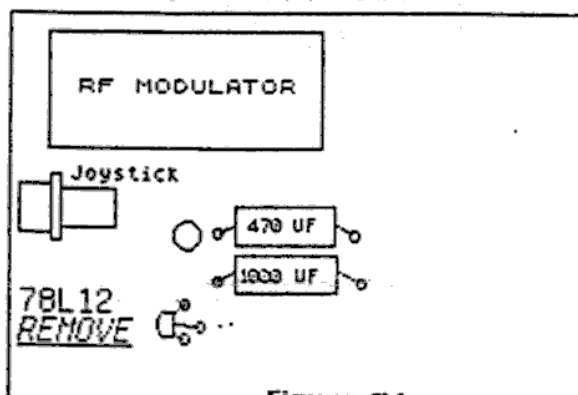
Figure #1

## INSIDE YOUR 2068

Using proper care, open your beloved 2068. Using Figure  
#1, find the 78L12 voltage regulator. It looks like an  
ordinary transistor (Only good for milliamps). Using great  
care, remove it. Make sure the holes are cleaned out. Now  
install the 78M12 (larger for more current) - Radio Shack  
part #276-1771, about \$1.50. Use Figure #2, noting that it  
is the BACK of the regulator that should be facing up.  
Now for the test! Move everything away from the circuit  
board, with the keyboard unattached, and power up.

Your 2068 should display the copyright notice. If it does  
not, power off immediately! Check the orientation of the  
7812. If you have a volt meter check the input and output.  
When you have everything going well, put your 2068 back  
together and gaze into your nice clean picture.

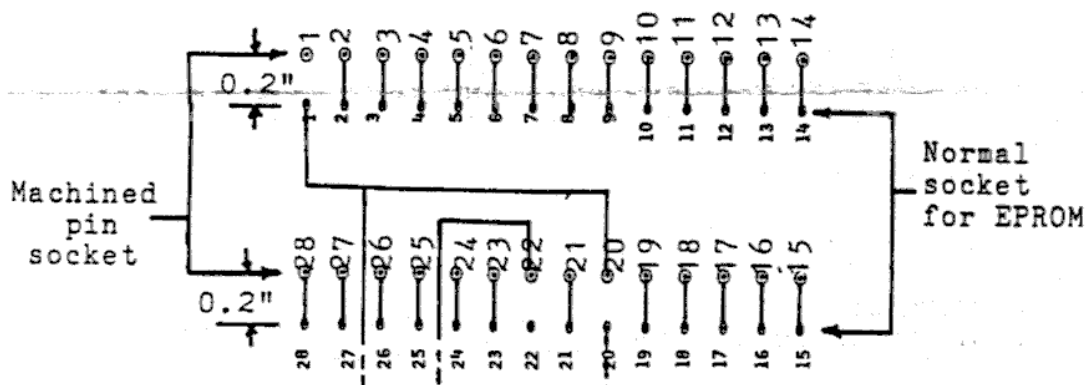
FIGURE: Partial back view of the daughter-board. The decoder IC, which on my board is a 74HCT00, is not shown.

protrude, and is fitted in the ROM socket on the QL mother-board. In order to install two sockets side-by-side one has to saw-off the stabilizing plastic bridges (two or three) which every socket has. The consequence of this is that when you want to install an EPROM in the normal socket, it flexes the socket rows sideways, so much so, that some times it is not possible to install the EPROM. This flexing causes the hairline cracks in the copper traces on the back of the daughter-board. Belatedly one discovers that in order to install the EPROM, one has to hold the two rows of the socket pins of the normal socket vertically by one hand, and then fit the EPROM in the socket. We discover this after we have already caused damage to probably more than one trace.

The second mechanism causing the cracks, is the way we normally install the flimsily made daughter-board, by pushing on the corners of the board. This method of installation causes too much pressure on the corner pins of the machined socket, and possible hairline cracks.

As such, the suggested procedure for installation is to first install the EPROM on the daughter-board, while holding the normal socket in a vertical position in one hand, thus avoiding the flexing of the pins of the normal socket. Second, install the daughter-board on the mother-board by pressing on the top of EPROM, thus causing the pressure to be equally distributed on all the pins of the machined socket.

All these hassles could have been avoided if the boards were properly manufactured. For example, metalization both on top and bottom of the daughter-board would have helped. Most importantly, instead of using a low cost machined socket, the use of DIP socket carrier (say Dig-Key #ED6028, \$3.26) would have totally solved the problem. In this case you will have the benefit of machined pins, with the pins flush on top, thus allowing the normal socket straddle the socket carrier pins on top, without the stabilizing plastic bridges being sawed-off. But as you can see, this will almost double the price of the daughter board.

The hairline cracks that I mentioned, are hard to see, even under a magnifying glass. Static testing by continuity measurements (using a VOM) could also be misleading. One can dynamically test by say, using a logic probe. One may even be tempted to cure the problem by putting solder globs on the affected traces. I recommend against it. The only sure method of solving the problem is, to do point-by-point wiring between the pins of the two sockets. This is much easier than it sounds. As shown in the figure, the two sockets are separated by a distance of 0.2", with all the respective pins connected by copper traces, excepts pins 1, 20, and 22. I use bare wire-wrapping (28 gauge) wire. Make a tiny hook on one end of the wire, solder it to the pin, wrap the wire on the corresponding pin of the other socket for half a loop, solder and cut the wire with a razor blade or Xacto knife at the base of the pin. Do all the 25 pins shown in the diagram. This will, with high probability, solve your problem. In the worst case you may have to duplicate all the traces on the back of the daughter-board using wire-wrap wire. Do not use a soldering iron rated higher than 15 watts.
